BERMAD Irrigation

IOM IR-23Q

Pressure Relief Valve

(Sizes 1.5"- 2"; DN40-DN50)

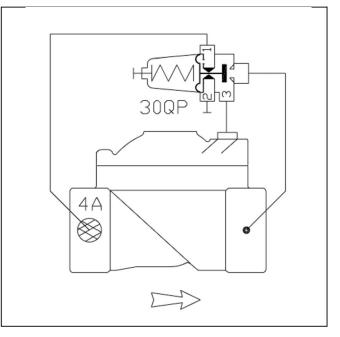
The BERMAD Model IR-23Q Quick Pressure Relief Valve is a hydraulically operated diaphragm actuated control valve that that excessive line pressure when it rises above the preset maximum. It responds to a rise in system immediately, accurately and with high repeatability, by Opening fully. The IR-23Q provides smooth drip tight closing.
